# CONCRETE CONSTRUCTION

# ITS FIRE-PROOF QUALITIES

# REPORT SUBMITTED TO THE INSURANCE ENGINEER-ING EXPERIMENT STATION, EDWARD ATKINSON, DIRECTOR, ON THE CONFLAGRATION IN BALTIMORE.

By PROF. CHARLES L. NORTON.

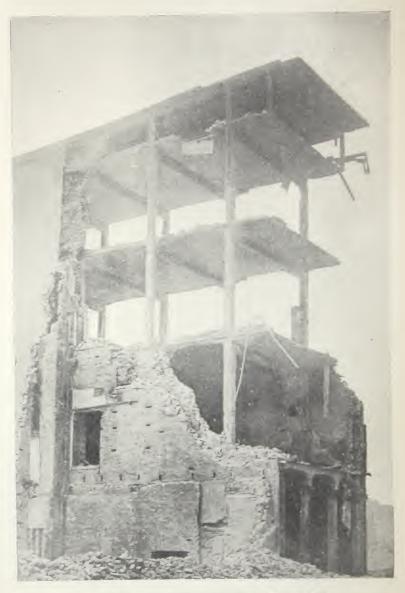
FERRO CONCRETE STRUCTURE STANDING AFTER THE FIRE.

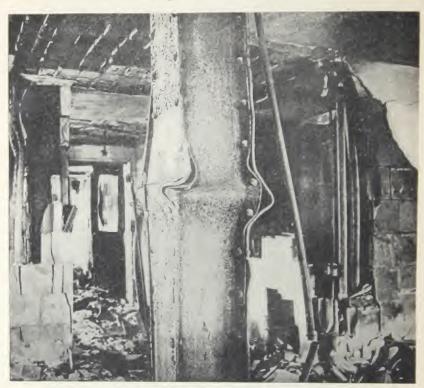
THE CRUSHED POST IN THE CALVERT BUILDING.

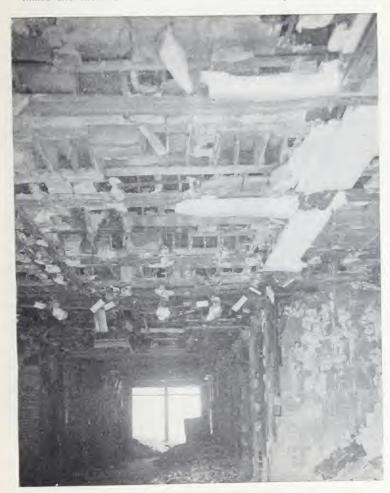
TERRA-COTTA CEILING OF THE CORRIDOR—CONTINENTAL TRUST BUILDING.

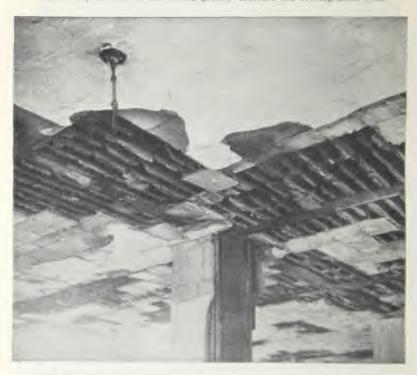
SHOWS CONDITION OF A LARGE PART OF THE TERRA-COTTA PLOGE ARCHES

The floor arches of many different spans and of different details of construction, but in the main of terra-cotta or lime-teil, show much the same sort of distress as the partitions. The bond between the tiles is broken, quite generally, and the tiles themselves are cracked and broken

in great numbers. The lower face or soffit of the tiles has split off over large areas, and 50 per cent. or 60 per cent. of the terra-cotta floor construction will, I fear, need to be replaced or reinforced.

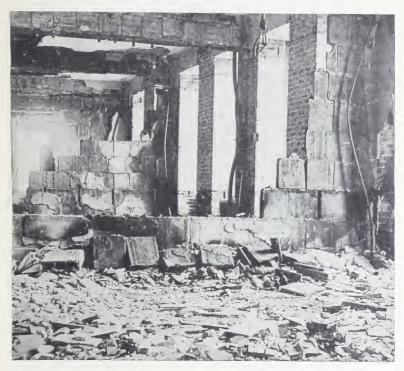
A ROOM IN THE CALVERT BUILDING, SHOWING FAILURE OF PARTITIONS.

The partitions of terra-cotta and lime-teil are very largely destroyed and the unfitness of these materials for this purpose seems clear. Many partitions have fallen and more are in such condition that they must be replaced. Much of the lime-teil is softened and the terra-cotta is cracked or broken and the bond between blocks is loosened. If metal lath partitions were in existence to any great extent, they failed as well, for few were in evidence in good order.

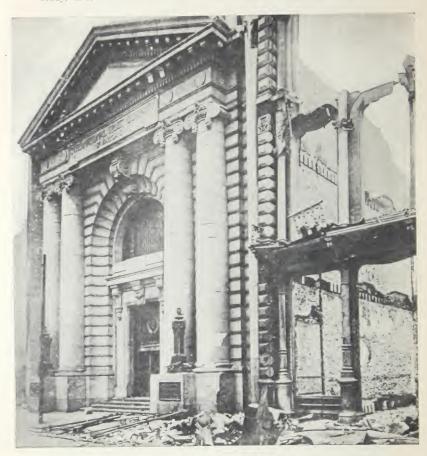
INTERNATIONAL TRUST COMPANY, IN PART CONCRETE STEEL; SKYLIGHT CRUSHED BY FALL OF NEIGHBORING WALLS.

Further, in the International Trust Company Building a small paper room laving a Hennebique floor and ceiling, was so intensely heated that at the end of three days the lumps of cast iron which had earlier been a copying press and an embossing stamp were still red hot, and yet neither floor nor ceiling show signs of distress. This is the more remarkable in that the walls of the adjoining building fell through the skylights

upon the Hennebique floor There were in the Commercial and Farmers' National Bank and in the National Bank of Commerce concrete floors, which stood the fire test well.

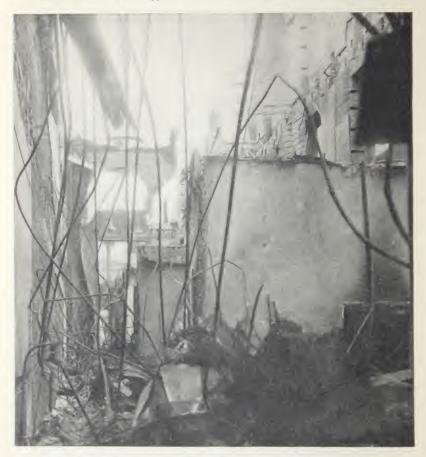
VIEW ABOVE CONCRETE FLOOR OF COMMERCIAL AND FARMERS NATIONAL BONK. SHOWING DESTRUCTION OF BUILDING AND CONTENTS.

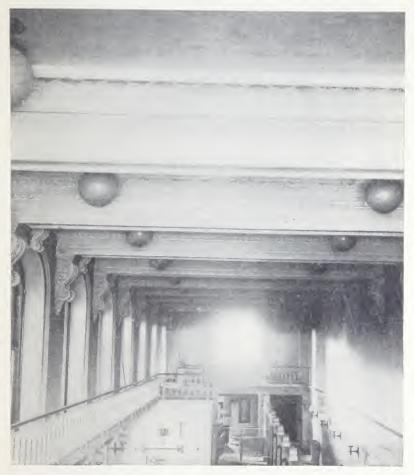
VIEW OF ROOM BELOW THE CONCRETE FLOOR IN THE COMMERCIAL AND FARMERS' NATIONAL BANK.
